STATE OF MICHIGAN
DEPARTMENT OF ENVIRONMENTAL QUALITY
LANSING

August 20, 2009

SUBJECT: G&H Landfill Superfund Site, Review of January – July 2008 Report

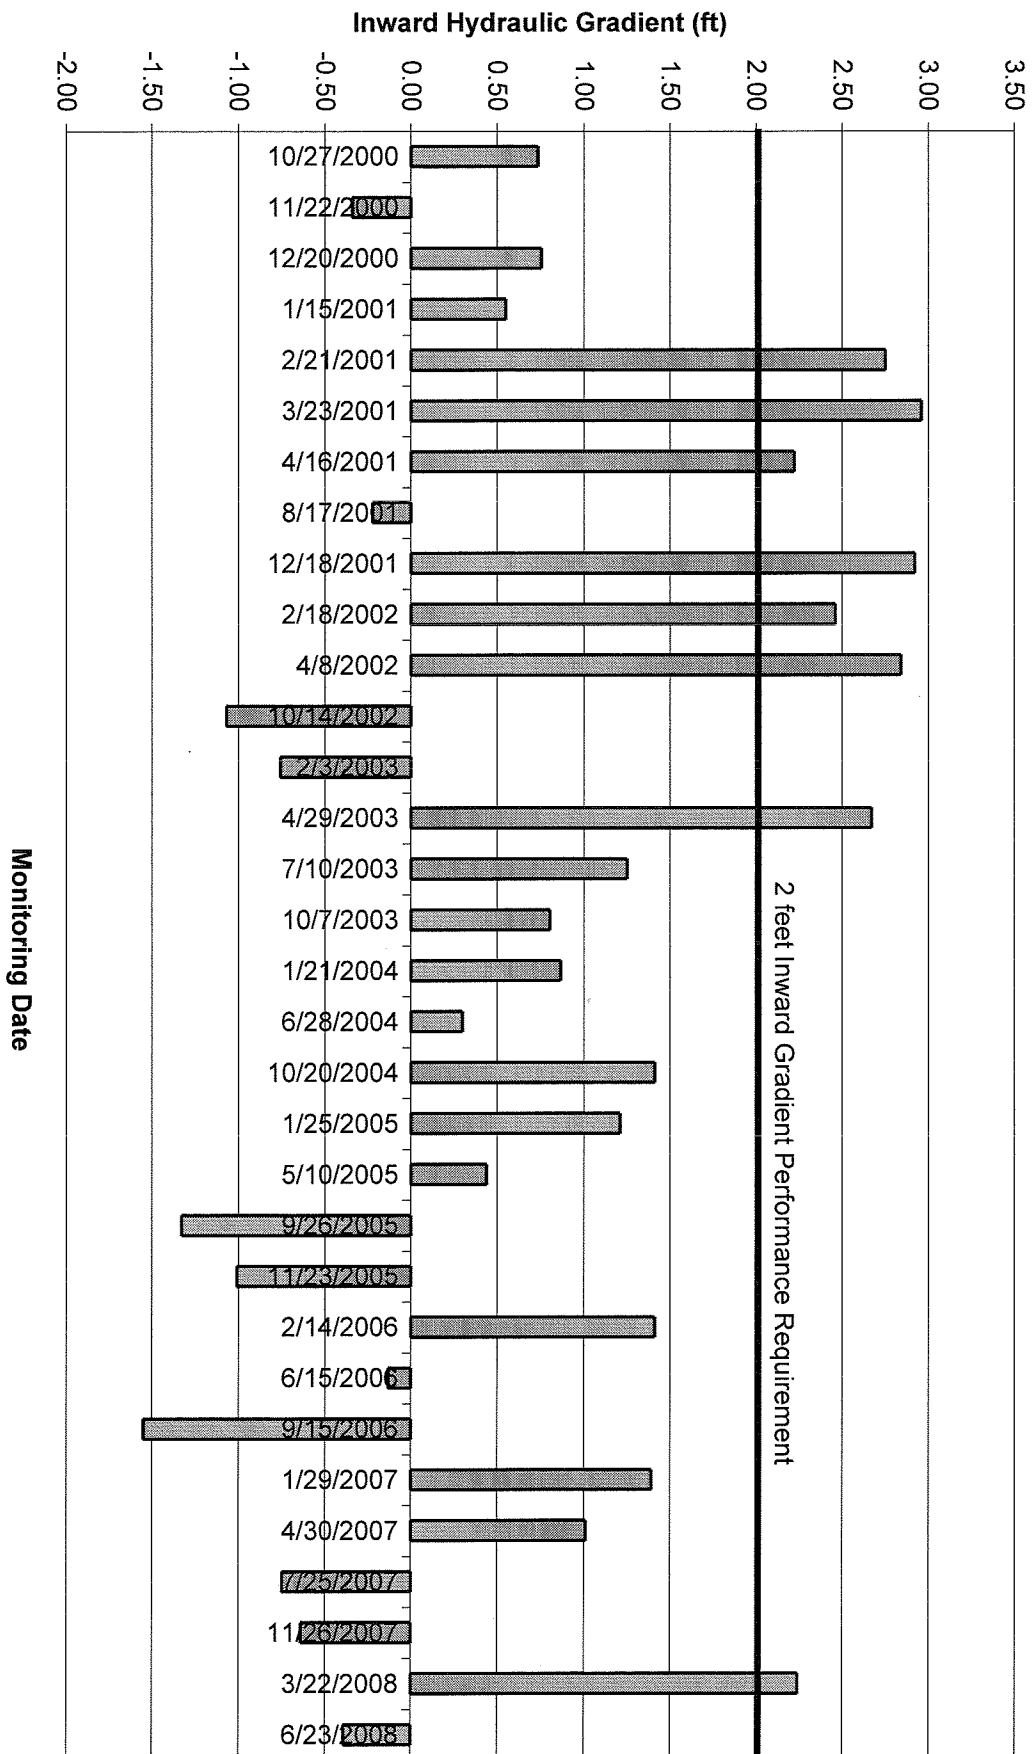
**Chart 1: Slurry Wall Inward Gradient Summary at GH-52/GH-53
G&H Landfill Superfund Site, Utica, MI**

- Has been achieved and maintained at the GH-56/57 pair;
- Has been initially achieved and maintained, but has been lost in recent years at pairs GH-60/61, GH-80/81, and GH-82/83; and
- Has rarely been achieved at pairs GH-52/53, GH-54/55, GH-58/59, and GH-78/79.

Charts 1 through 8 also show that an outward gradient occurred frequently at pair GH-52/53 and occurred at pair GH-58/59 for most of 2007.

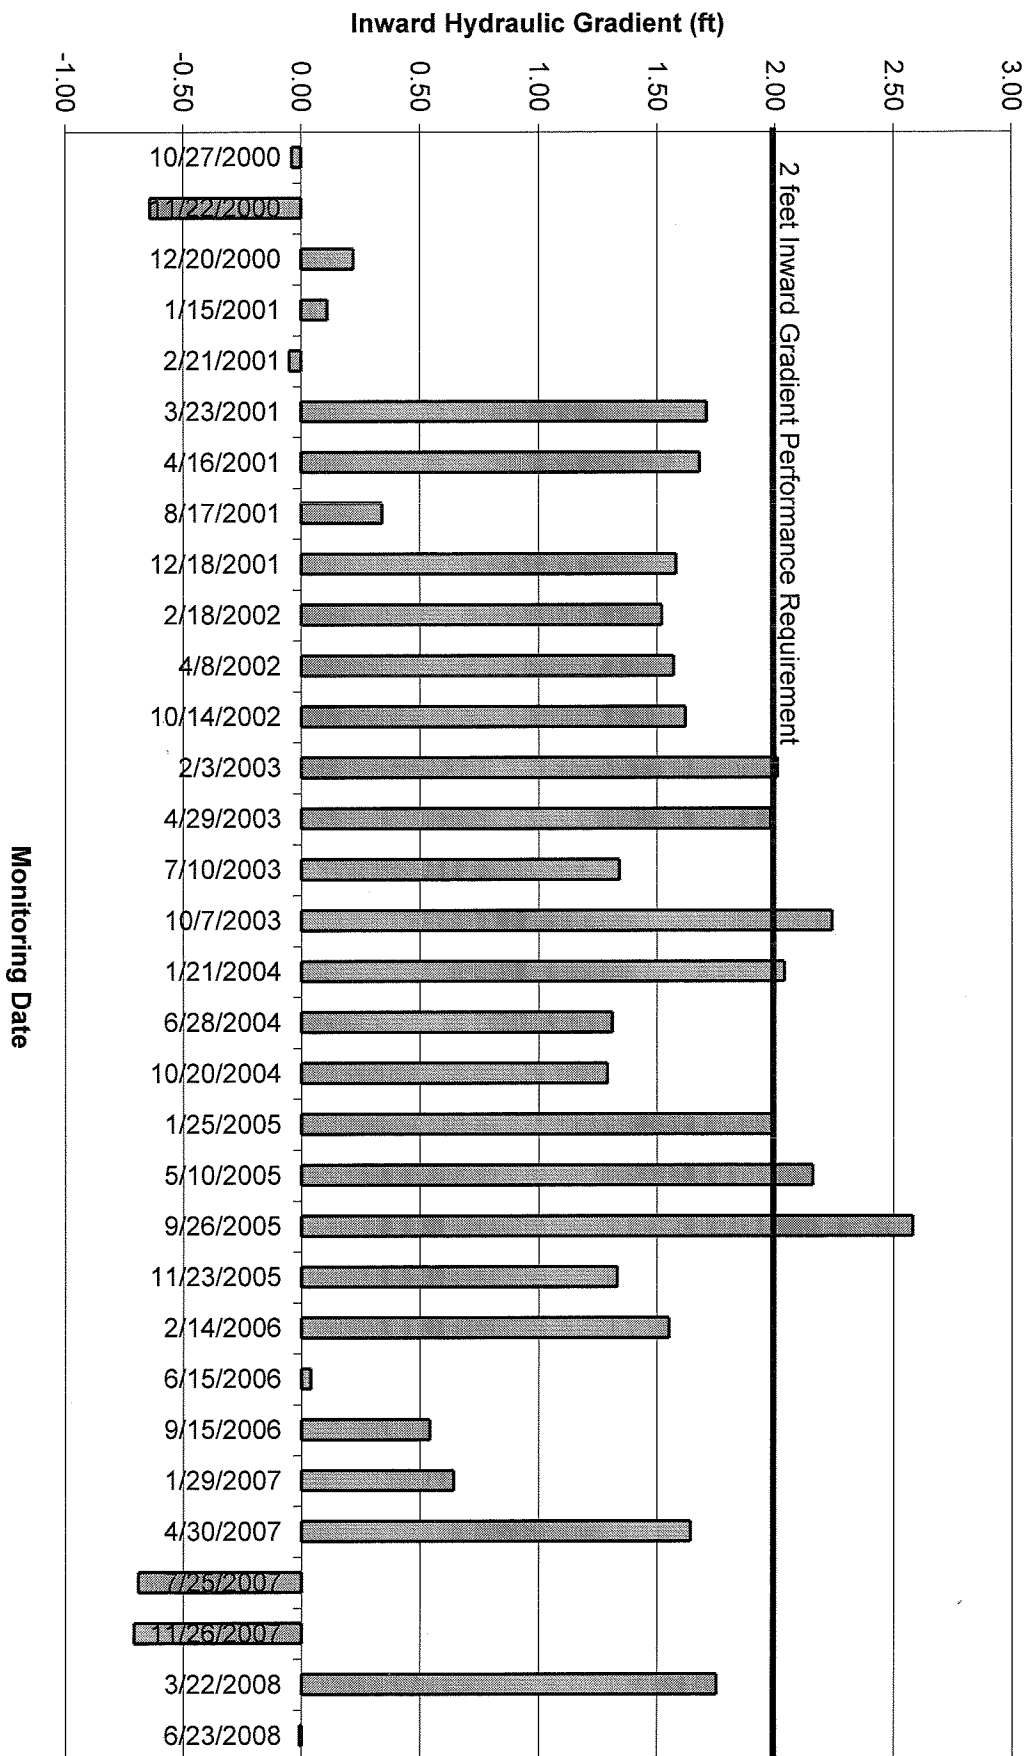
**Chart 4: Slurry Wall Inward Gradient Summary at GH-58/GH-59
G&H Landfill Superfund Site, Utica, MI**

CRA reports that an inward gradient was maintained along most of the barrier wall with a slight outward gradient at well pair GH-58/59 and that downgradient sampling at GH-59 demonstrates stable chemical concentrations. The performance requirement for the barrier wall and associated collection system, as indicated in the SOW (II.B) is to "provide an inward 2.0 feet hydraulic gradient across the trench (i.e., the hydraulic head of the water table outside of the downgradient barrier shall be a minimum 2.0 feet higher than the hydraulic head of the water table on the inside of the downgradient barrier)." This performance requirement was met at 3 of 8 and 1 of 8 monitoring locations in March and June, respectively. Additionally, 1 location during the June monitoring event demonstrated an outward gradient (GH-58/59).

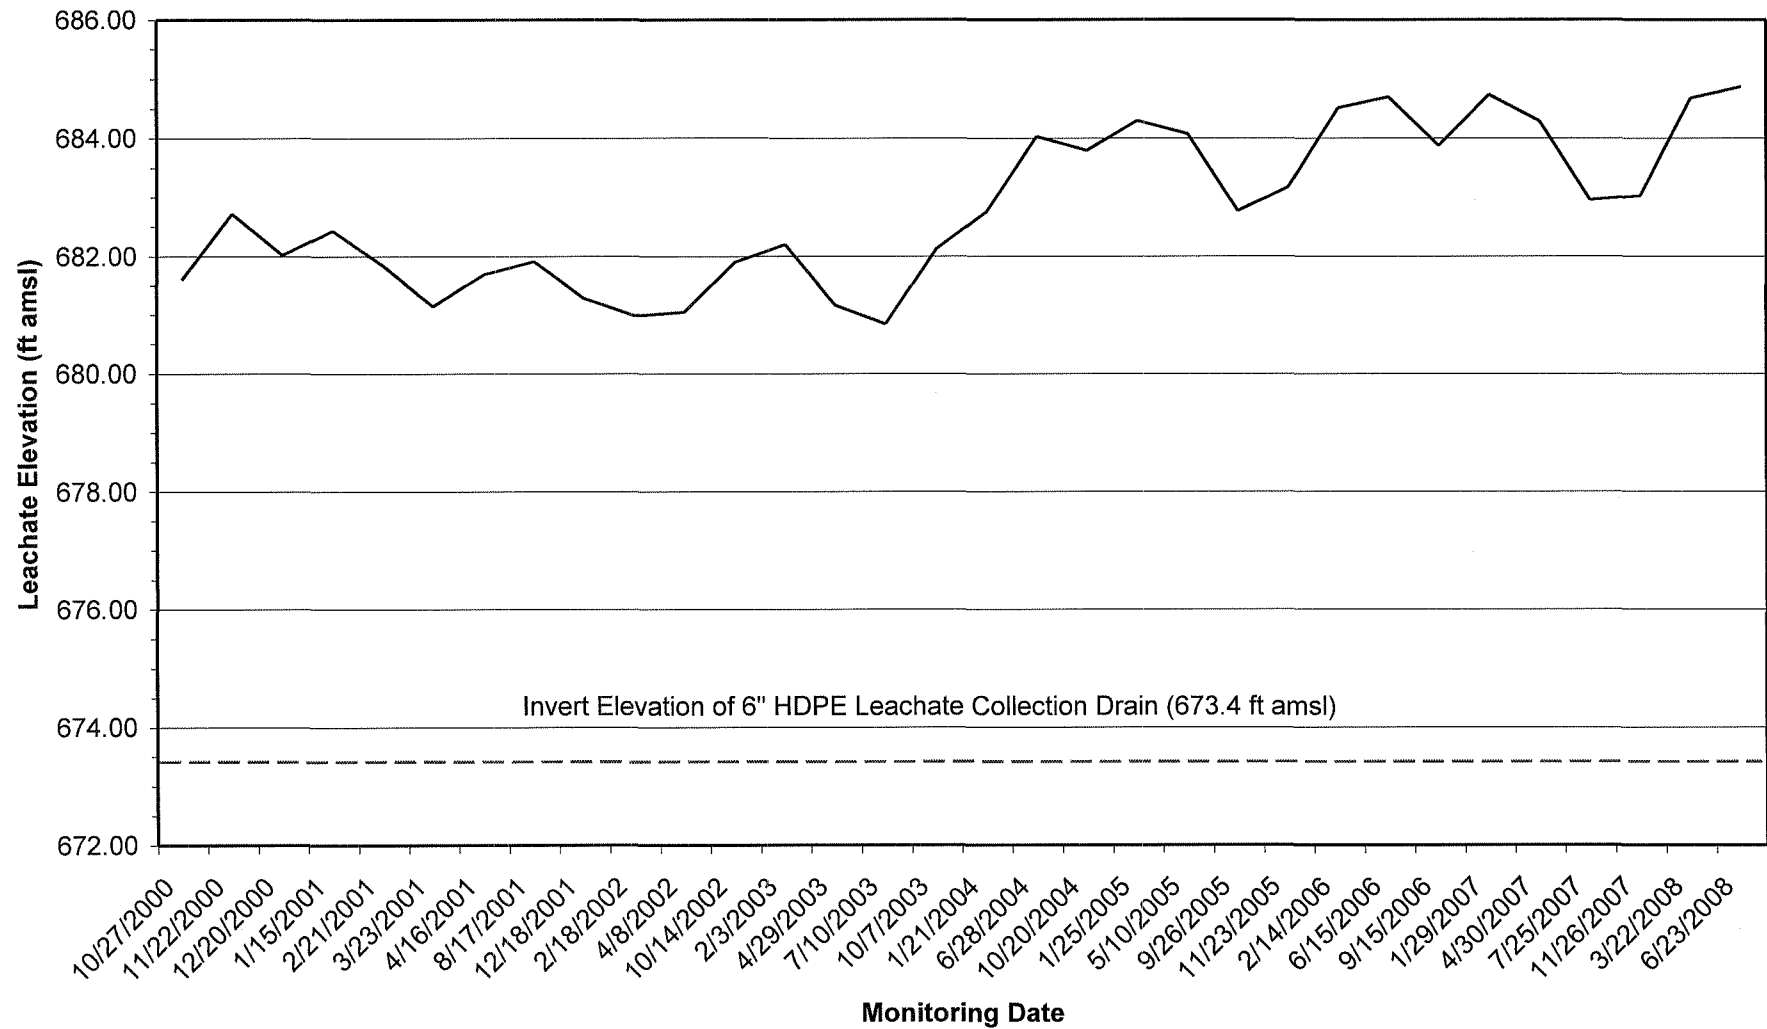
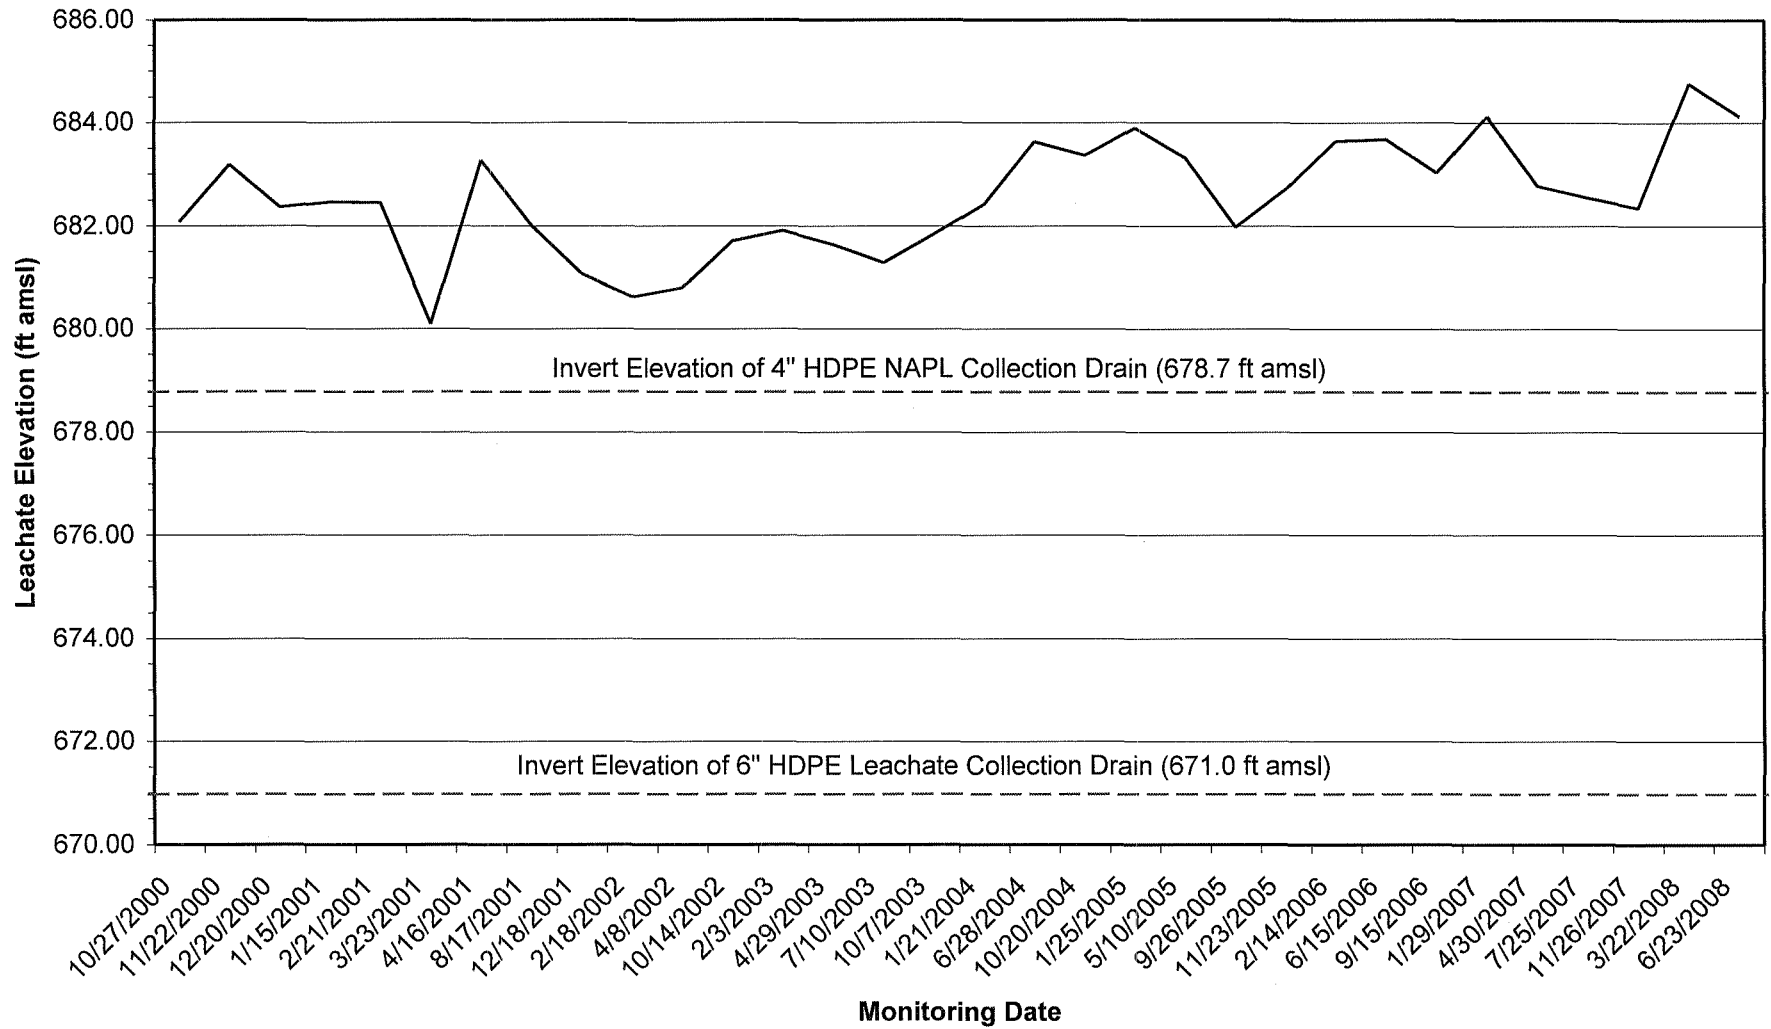
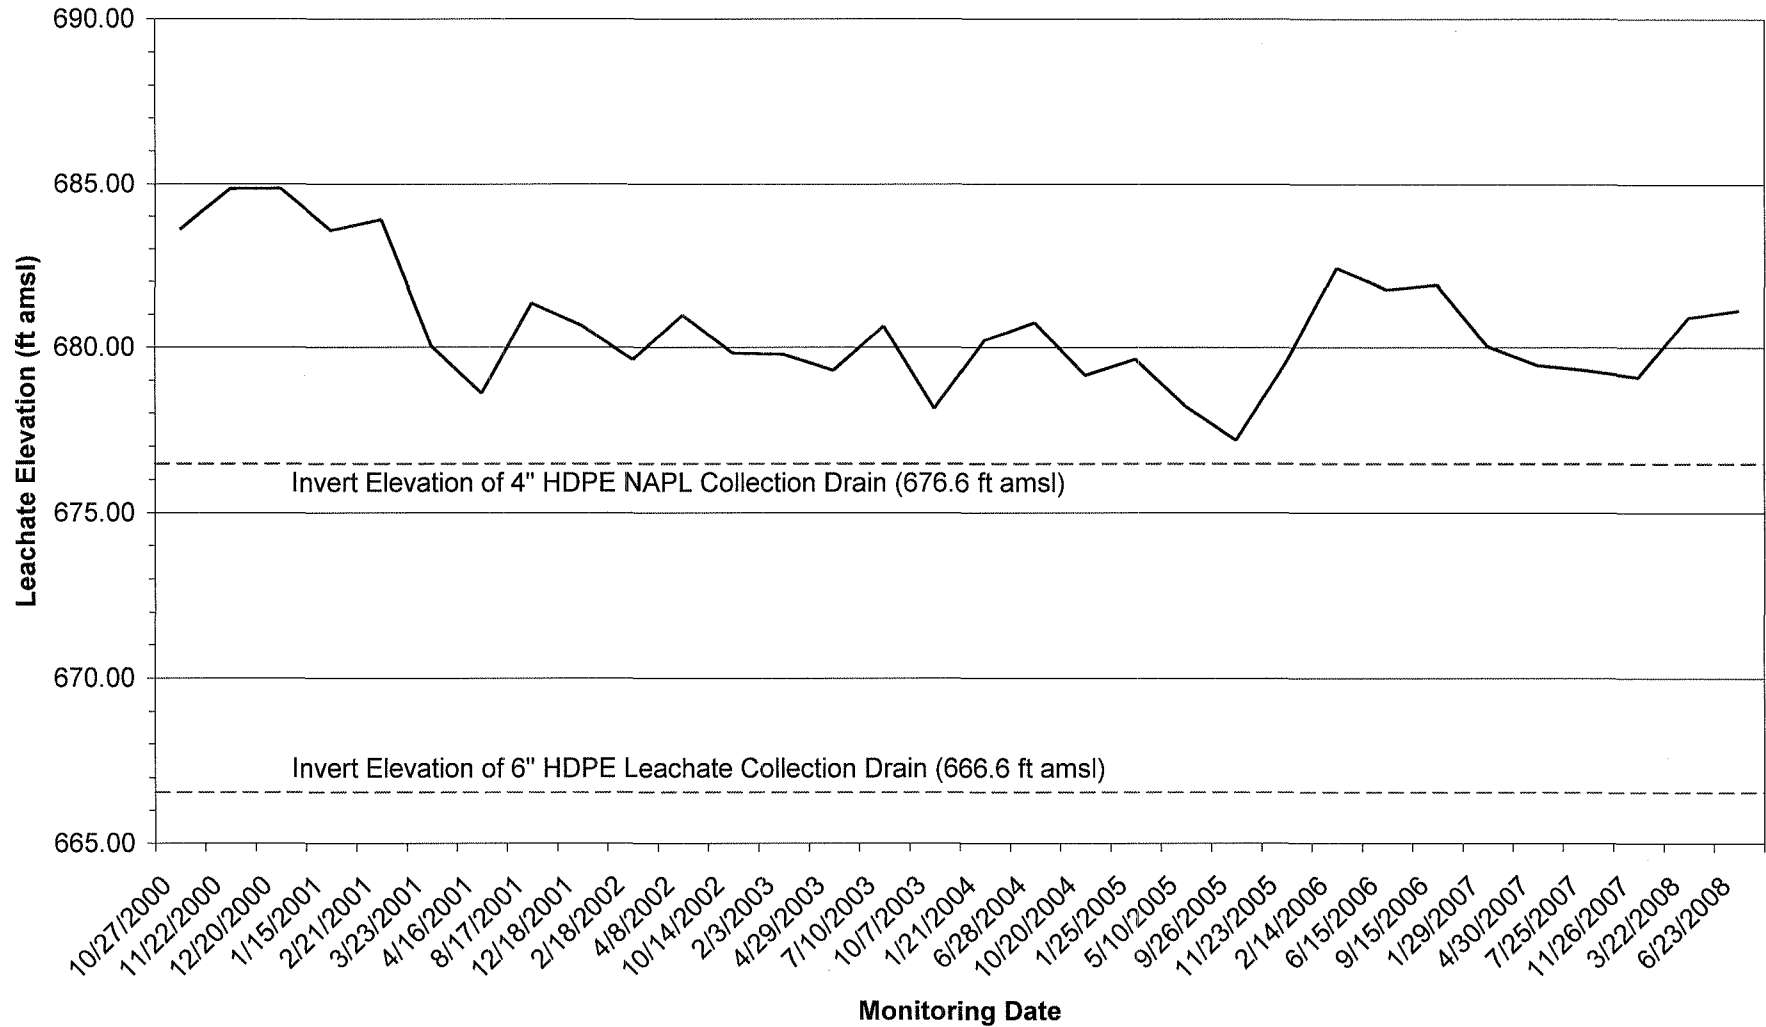
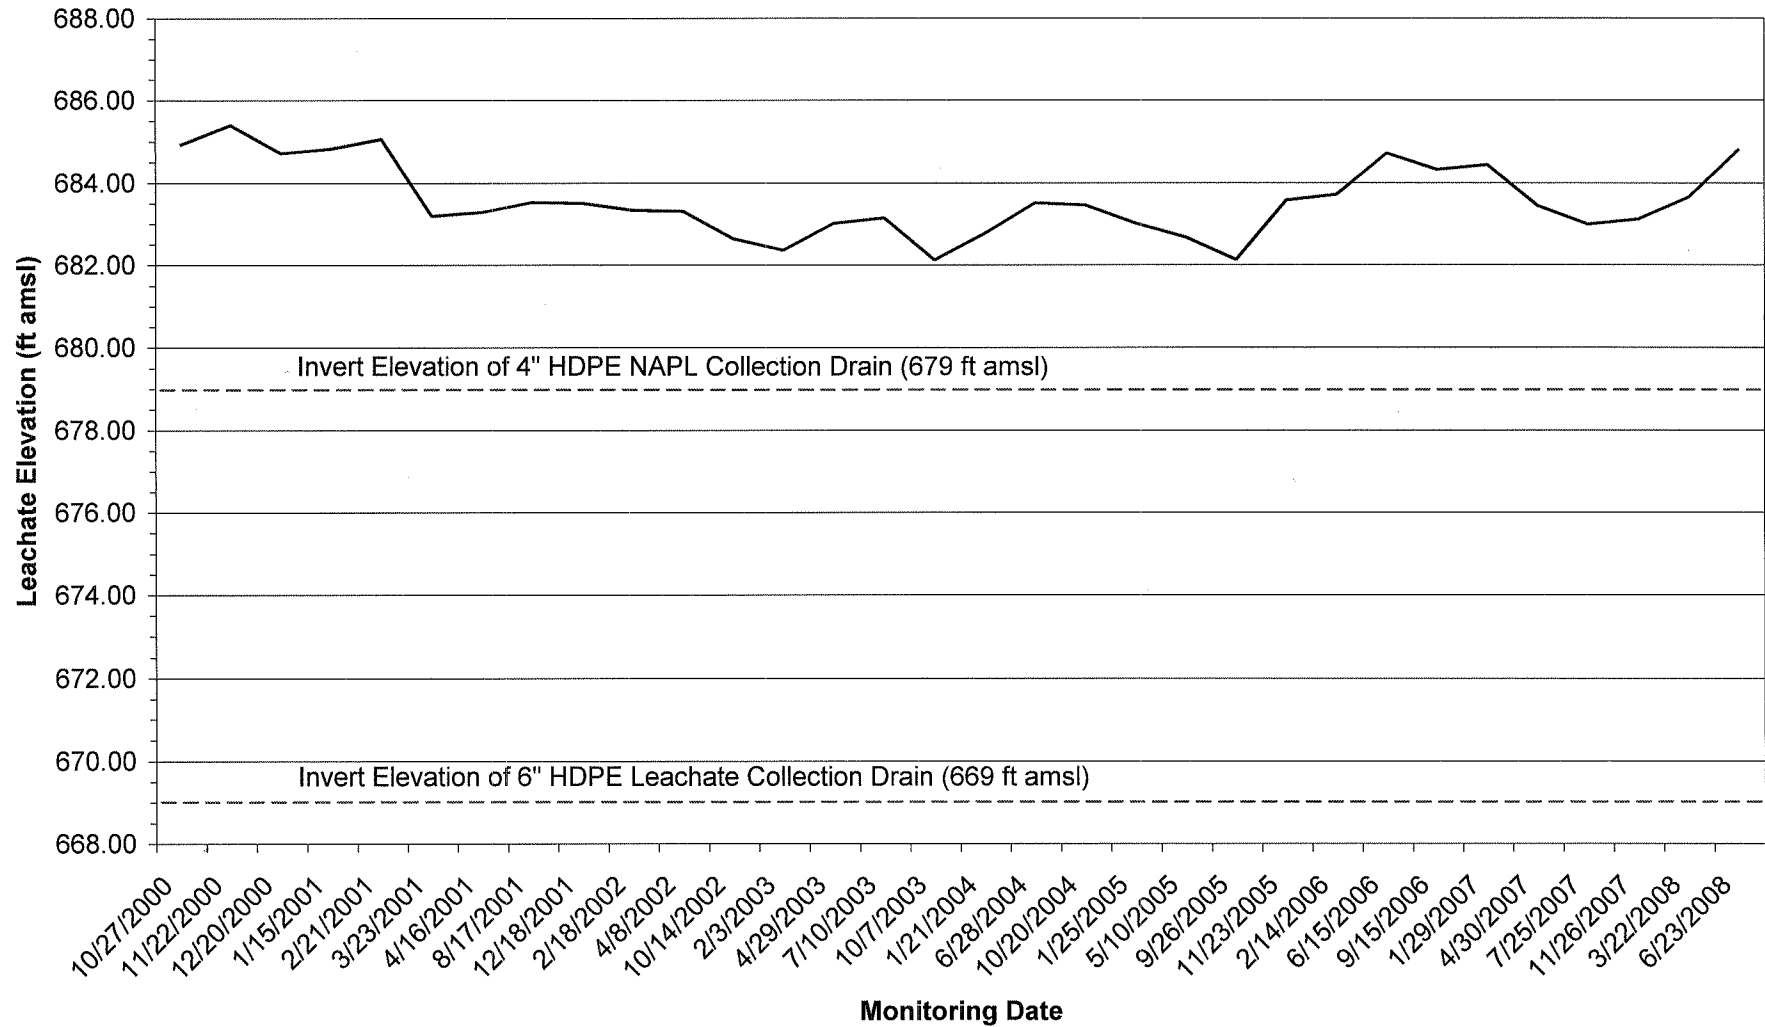
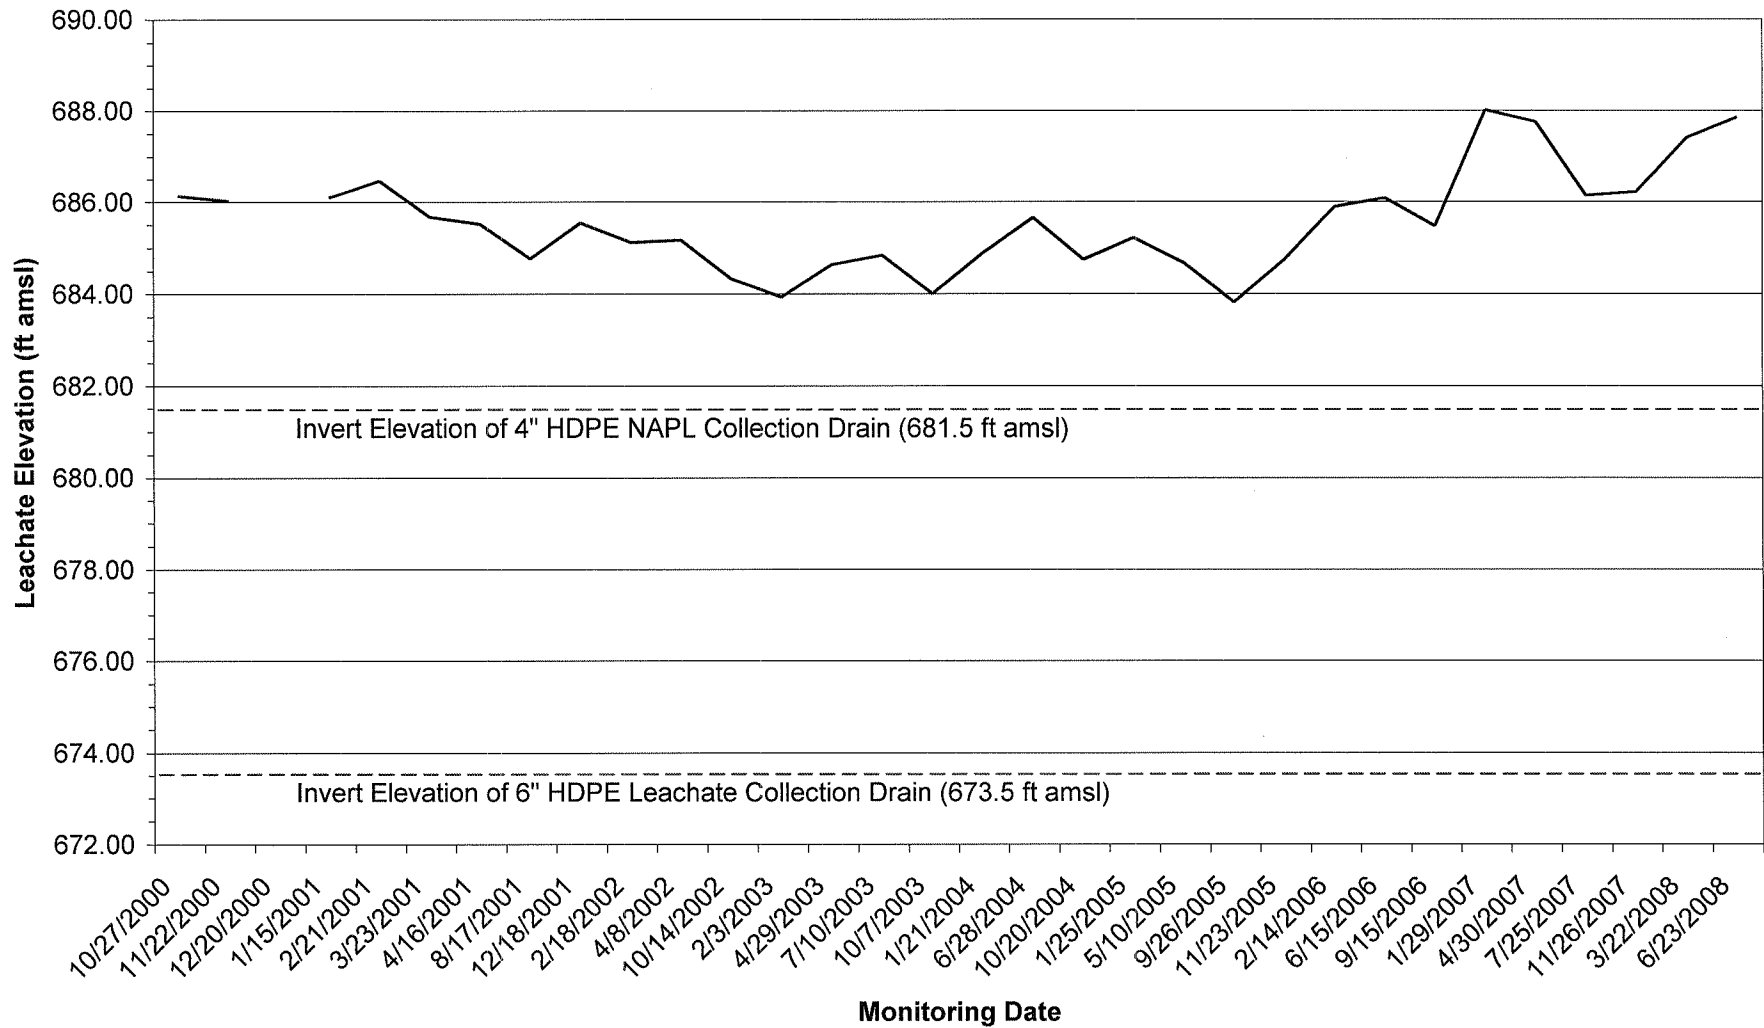
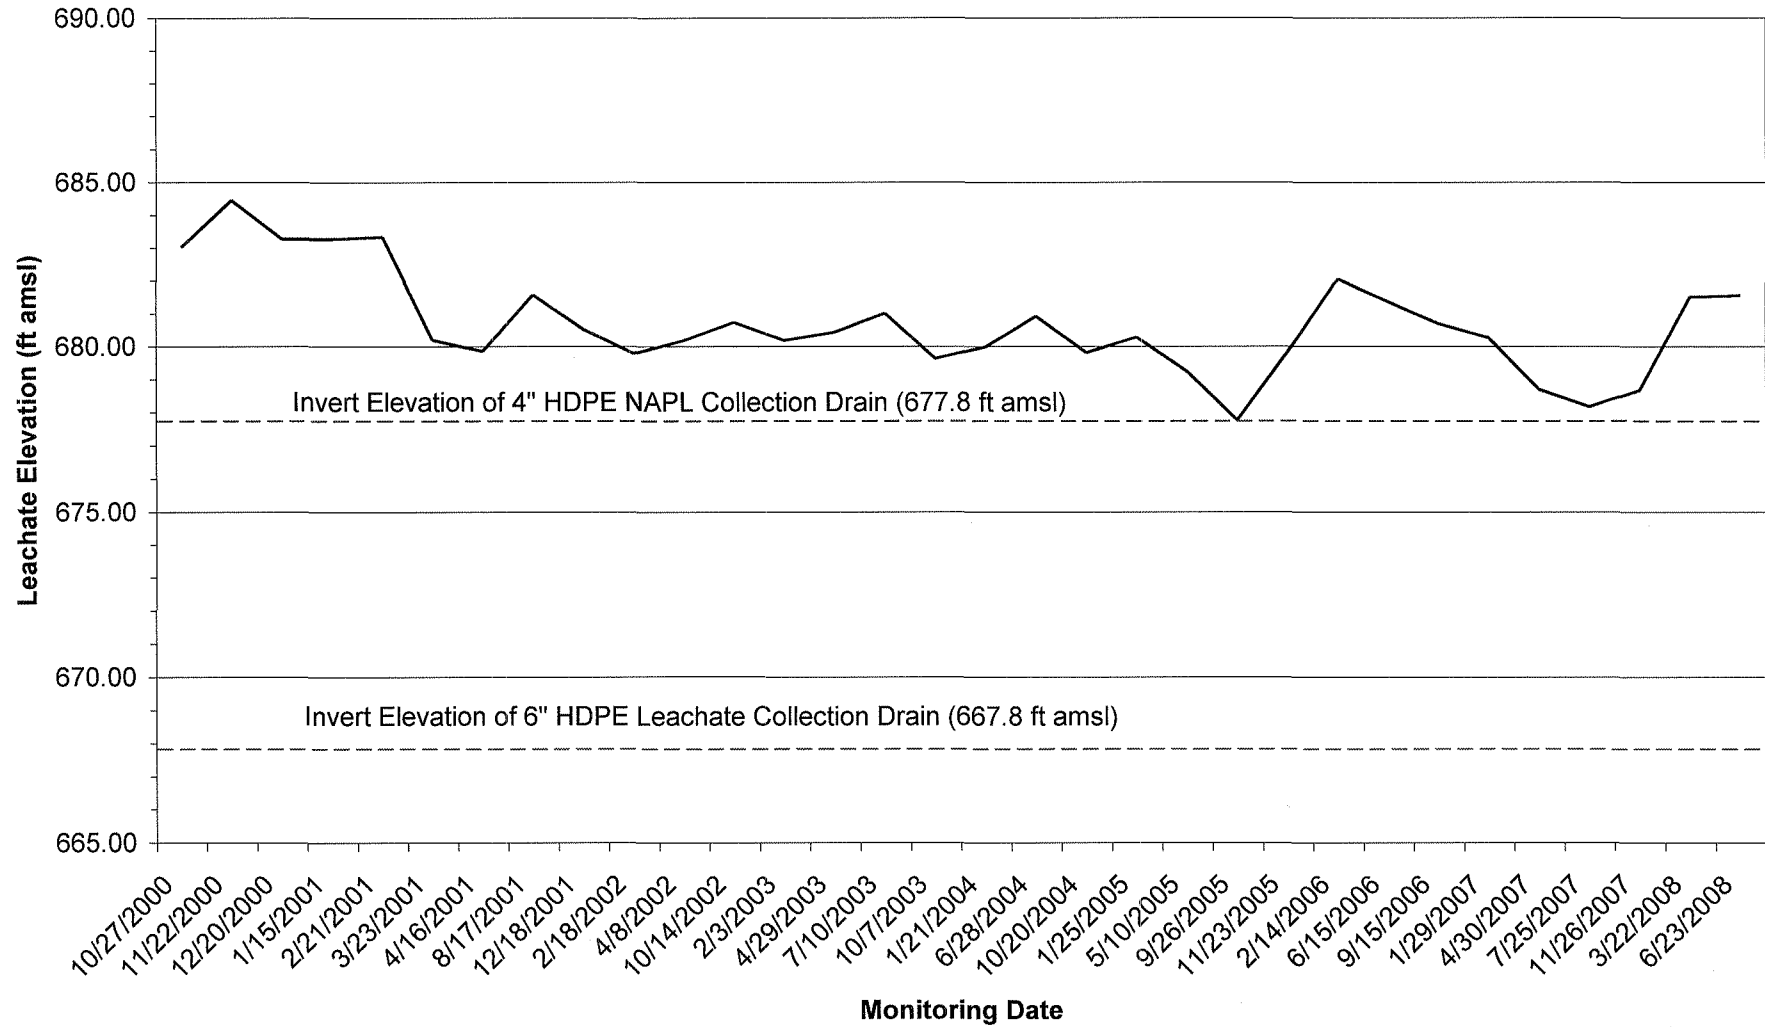
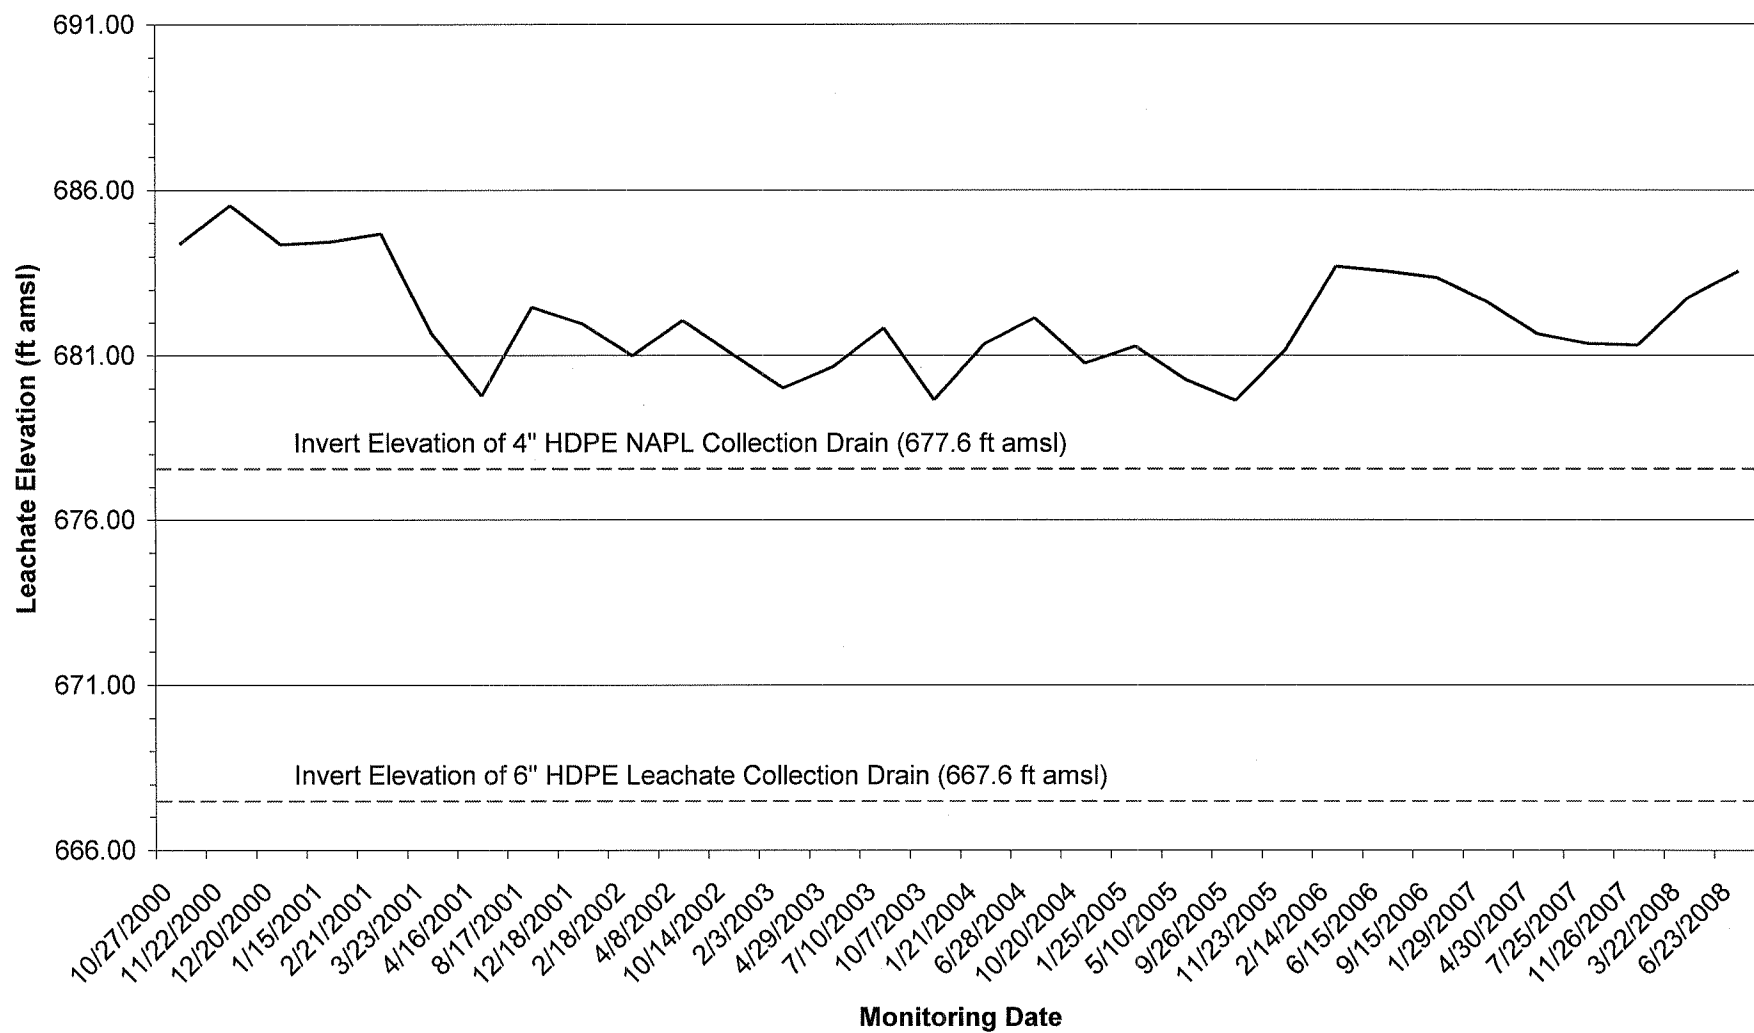
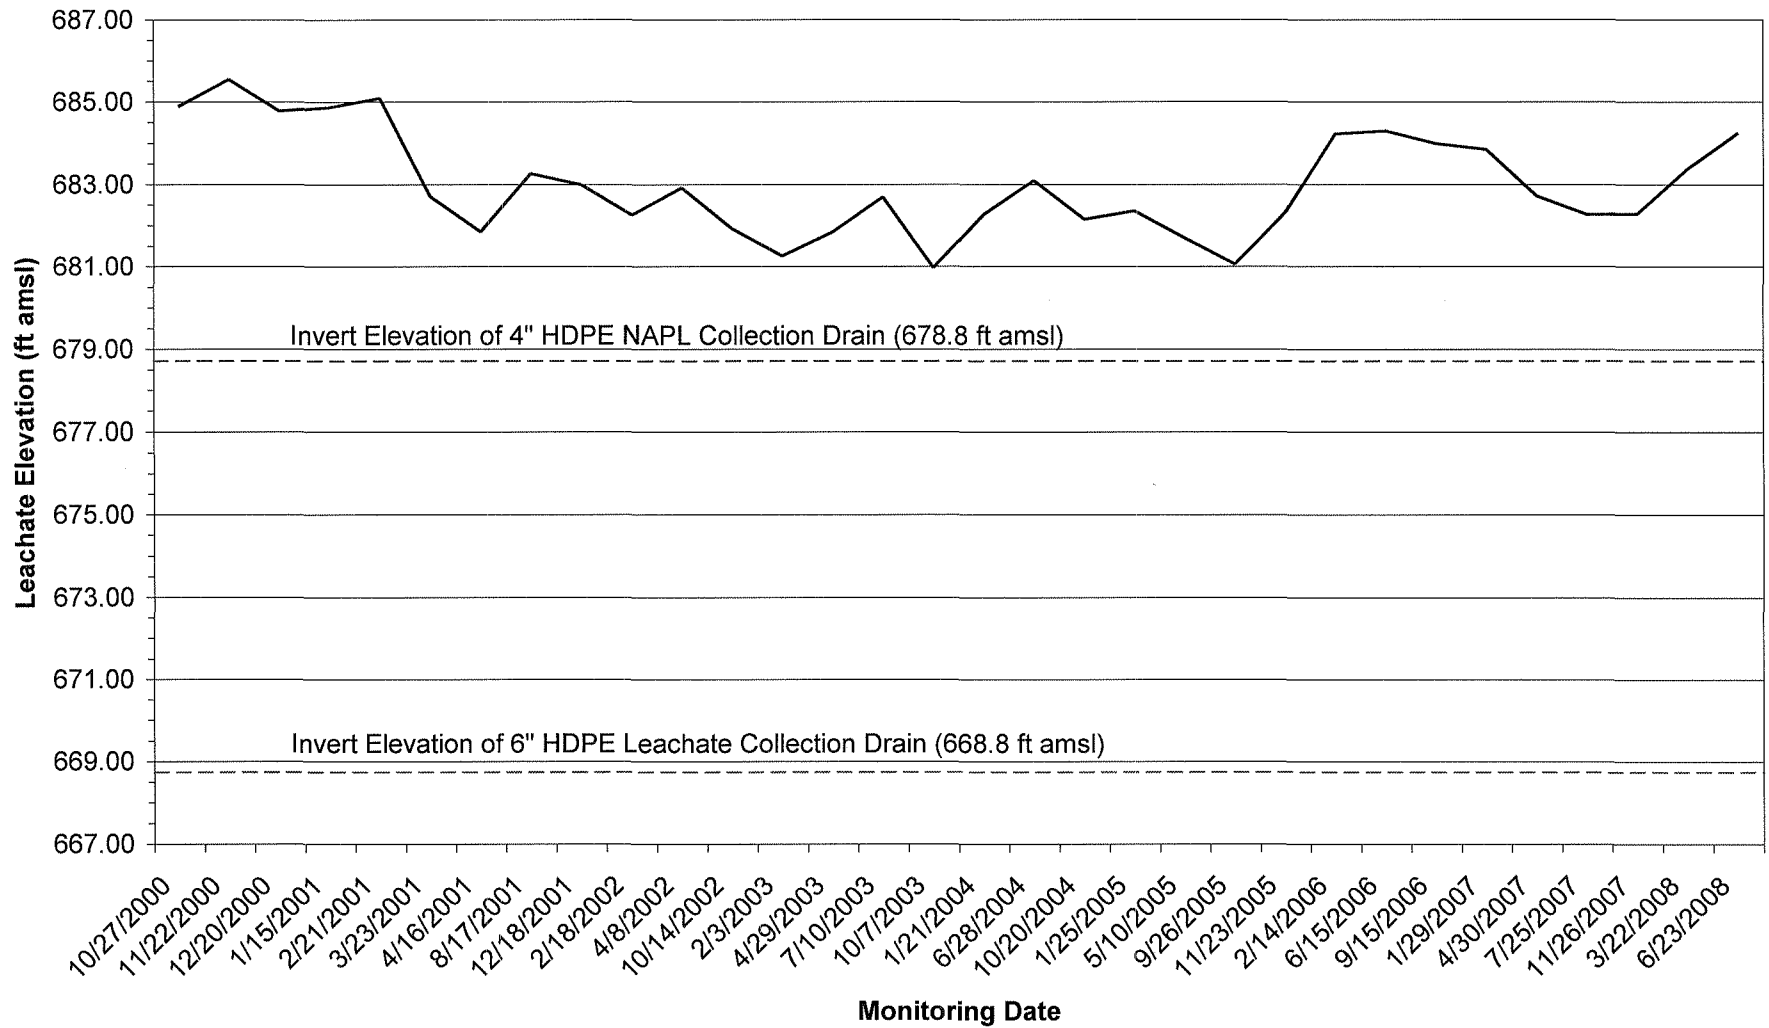
CRA reports water levels inside the barrier wall have remained stable. Water level trend charts, prepared by the MDEQ, are attached (Attachment B, Charts 9 - 16) for monitoring wells GH-52, GH-54, GH-56, GH-58, GH-60, GH-78, GH-80, and GH-82. The charts show water levels over time compared to the collection pipe invert elevations of the barrier wall collection system. The barrier wall collection system consists of a 6-inch high-density polyethylene (HDPE) leachate collection pipe and a 4-inch HDPE pipe, constructed approximately 10 feet above the 6-inch leachate collection pipe, to collect non-aqueous phase liquids (NAPL). The following observations are illustrated from the water level trend charts:

- Water levels have fluctuated approximately 2-3 feet seasonally within the capped cells with increasing trends observed at GH-52, GH-54, and GH-60 throughout the past 8 years of operation;
- Water levels have significantly exceeded the collection pipe inverts of the collection system throughout the past 8 years of operation;
- June 23, 2008, water levels at monitoring wells inside of the slurry wall range from 11.5 feet at GH-5 to nearly 16 feet at GH-80 above the invert¹ of the 6-inch HDPE leachate collection pipe; and
- June 23, 2008, water levels ranged from 3.75 feet at GH-78 to over 6 feet at GH-60 above the invert of the 4-inch HDPE NAPL collection pipe.

In summary, hydraulic and chemical data reviewed in this report do not present successful performance of the barrier wall and collection system at many monitoring locations. Additionally, the water level observed above the NAPL collection piping eliminates the ability of the collection system to retrieve NAPL.

- Implement the approved corrective action plan to achieve hydraulic and physical containment of the source areas;
- Execute contingency plans to achieve the 2-feet inward gradient at the barrier wall and maintain water levels to allow the collection of NAPL from the Phase I and Phase II landfill cells as required in the SOW;

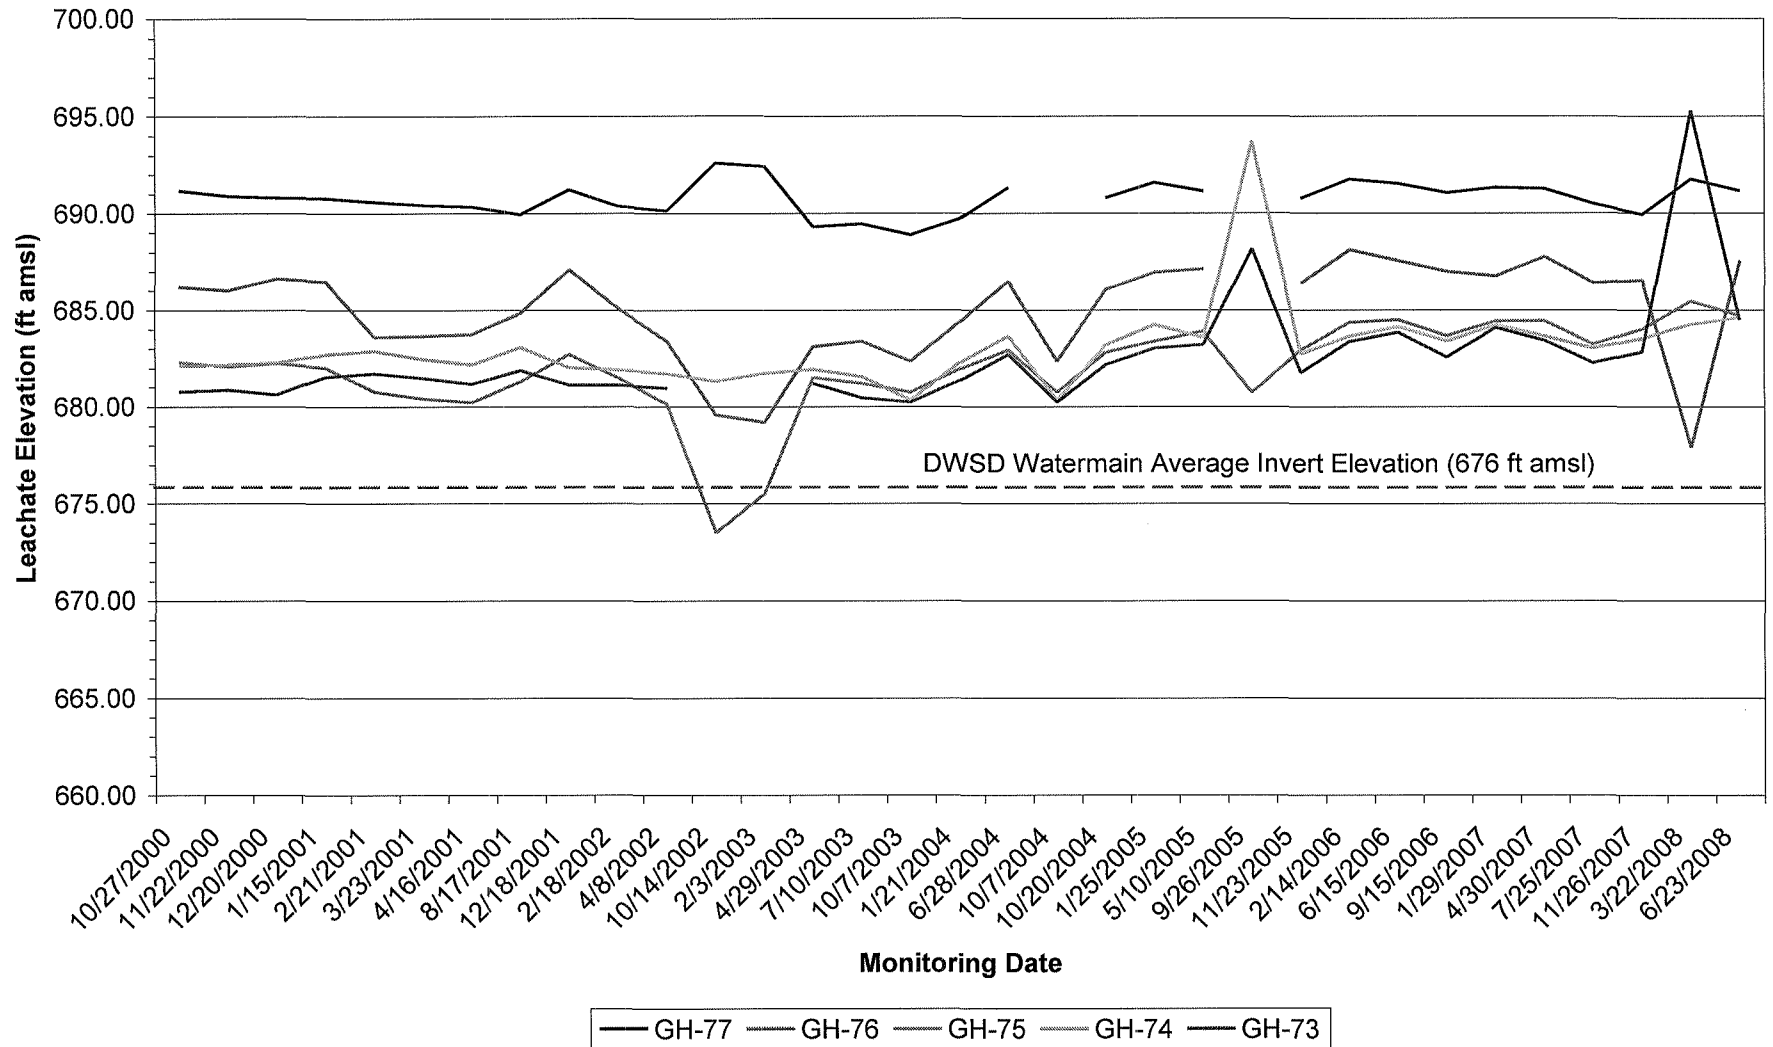
**Chart 17: Groundwater Elevations at DWSD Watermain
G&H Landfill Superfund Site, Utica, MI**

The OMP indicates the collection system adjacent to the DWSD watermain will be operated to maintain the invert of the watermain in a dewatered condition. Additionally stated in the SOW, "The well(s) shall be operated and maintained to continuously prevent the groundwater table or landfill contaminants from contacting the watermain." The MDEQ evaluated the elevation of leachate in monitoring wells adjacent to the DWSD watermain against the average invert elevations of the water. As shown on Chart 17 (Attachment B), the collection system has not met this requirement. One exception was noted for the October 2002 to February 2003 period where a leachate elevation was recorded to be below the invert elevation of the watermain at 1 of 5 monitoring locations (GH-75).

- Execute contingency plans to achieve hydraulic containment at the west end of the barrier wall and slurry wall as required in the SOW;
- Execute contingency plans to achieve hydraulic control around the DWSD watermain as required in the SOW;
